Manhole Inspection Summary

Manhole # S33AA1031MH

Insp Date: **10/22/08 2:55 PM**

Location Address: **3404 SAINT PAUL ST**

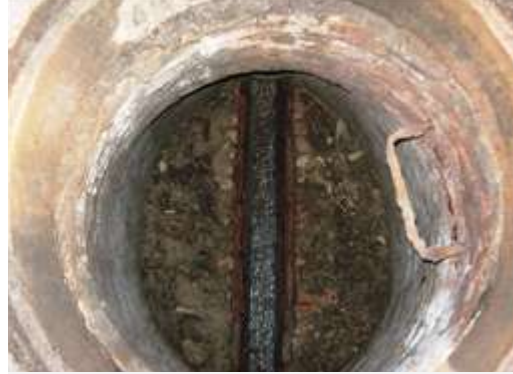
Top View

Corroded and missing steps. Evidence of surcharge - Bench debris.

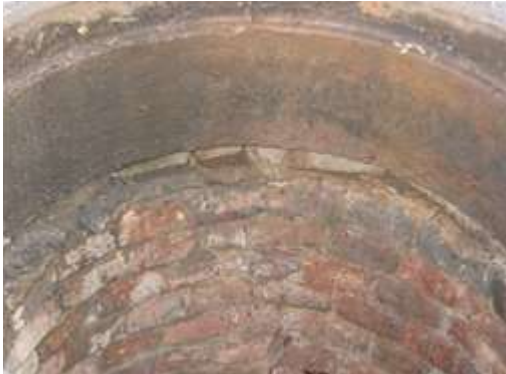
Defect

Frame leaks. Adjustment deterioration and infiltration - other side.

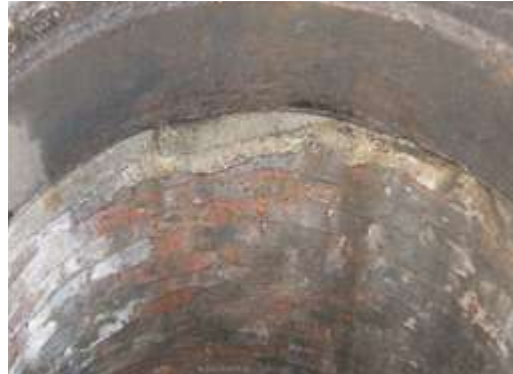
Defect

Frame leaks. Adjustment deterioration and infiltration.

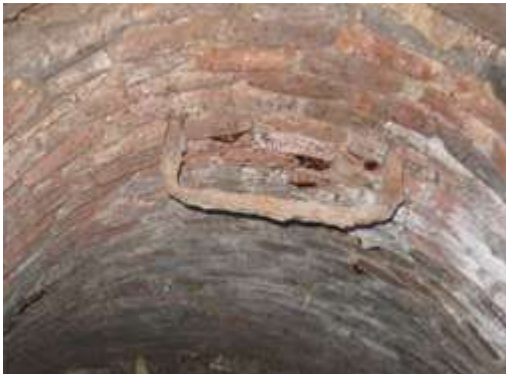
Defect

Corroded and missing steps.

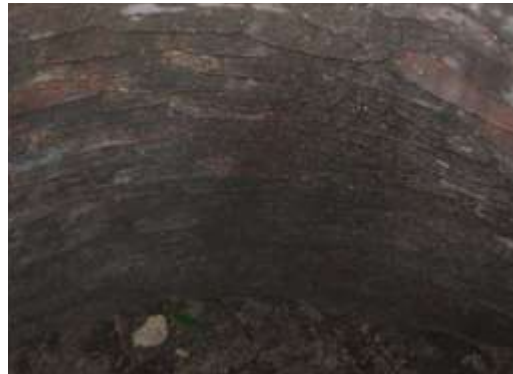
Defect

Barrel infiltration.

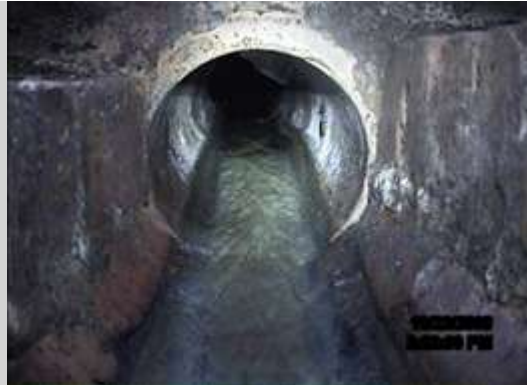
8 in. Circular Gravity Sewer Pipe Out @ 12 O'Clock

Deposits: ☐ None ☐ Mud ☐ Sludge ☐ Debris ☒ Grease

Silt Depth: **0** (in.) Deposits Extent: **Light**
